UV RESOURCES

# The Problem

# Coil Restoration

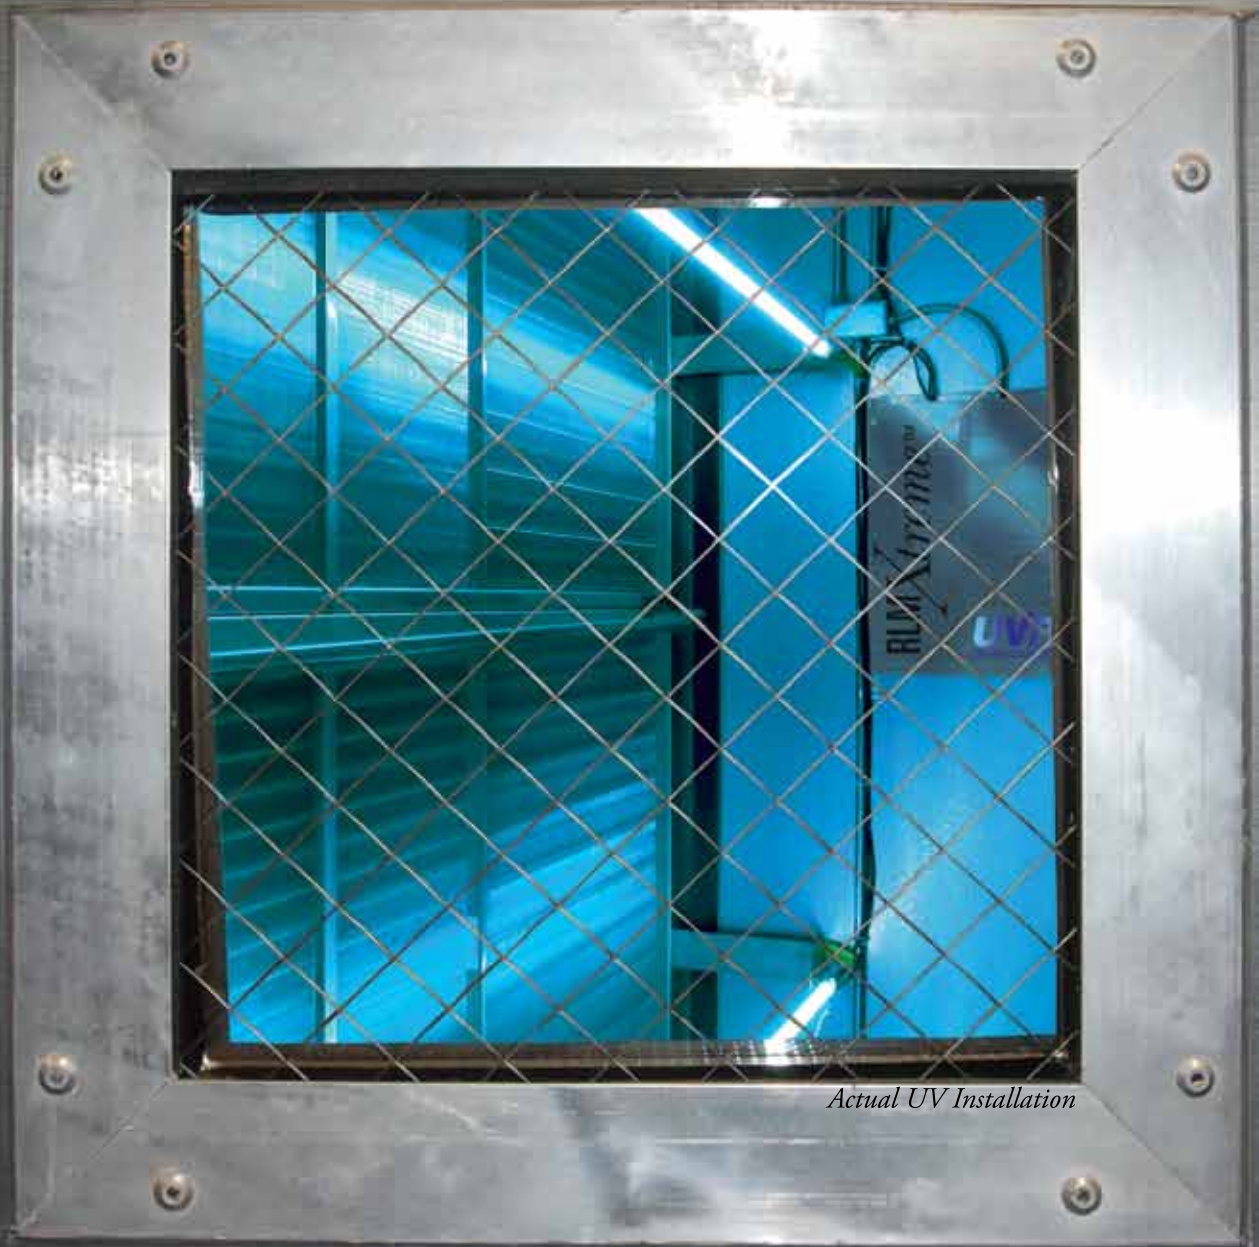
*Actual UV Installation*

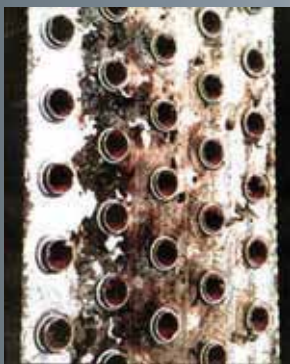
Cut Coil Shows Impacted Mold and Dirt  
Increased Pressure Drop  
Less Airflow  
Reduced Heat Transfer

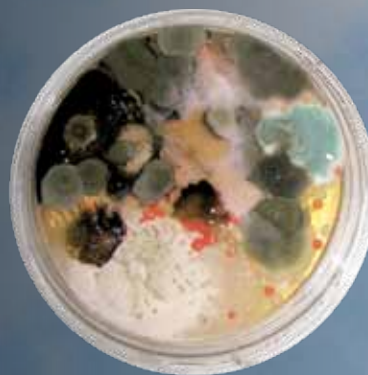
Coil Sampling Grows Mold in < 96 hours

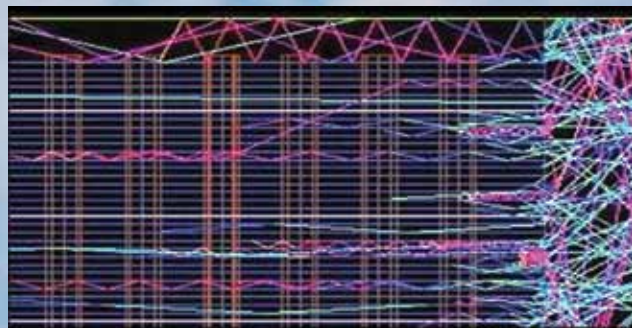
## Typical UV Reflection\*

\* Coil Plan View

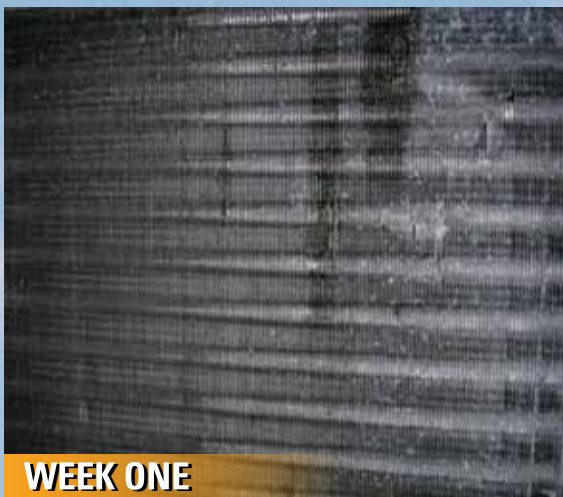
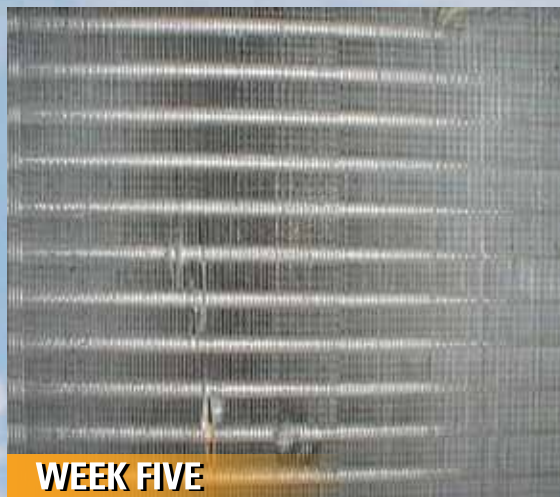
*Before and after pictures show fouled coils returned to as-built capacity.*

- ☑ Lowers pressure drop
- ☑ Increases airflow
- ☑ Provides colder air
- ☑ Restores efficiency
- ☑ Stops microbial growth
- ☑ Rids A/C of slime and odor
- ☑ Eliminates coil cleaning
